Dairy Dreams
Site Inspection April 16, 2014

CAFO WPDES Compliance Report (06/23/2014)

Inspection Date: 04/16/2014

Operation: Dairy Dreams

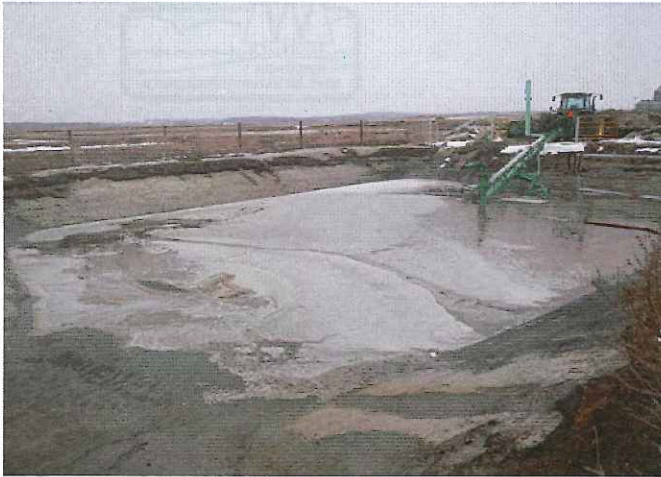
Top left: Photo of concrete lined manure storage pond located on the north east side of the facility. No MOL marker in this storage. Photo taken facing south east.

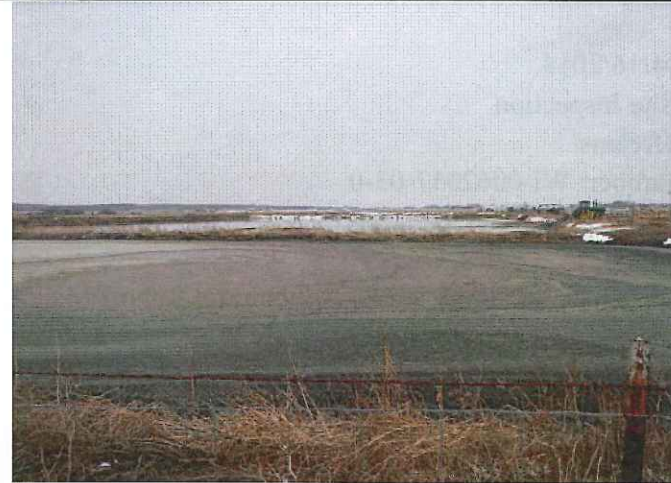
Top right: Photo of the three stage manure storage ponds. Stage one is concrete the other two are earthen lined. Permanent markers are present in all three storages. At the time of the inspection the storage had approximately 4 feet of freeboard and two feet until the storage was at its MOL. Photo taken facing west.

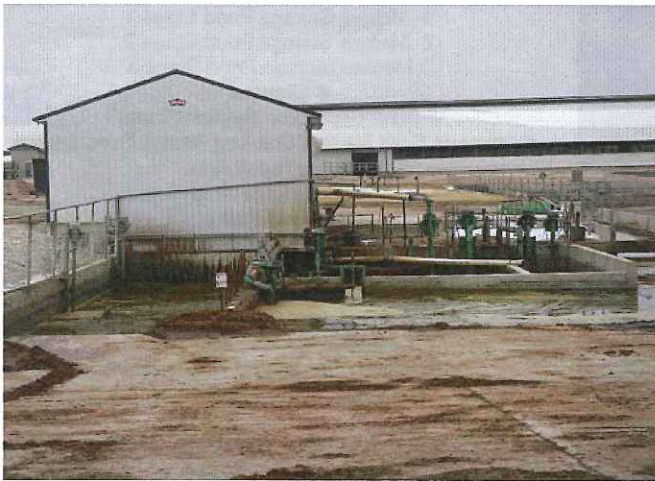
Bottom left: Photo of the sand separation system/flume for digester. Photo taken facing north.

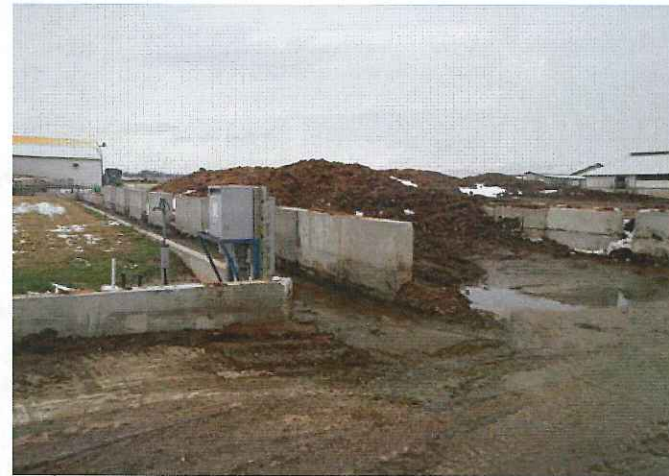
Bottom right: Photo of the concrete manure stacking area. Photo taken facing north west.

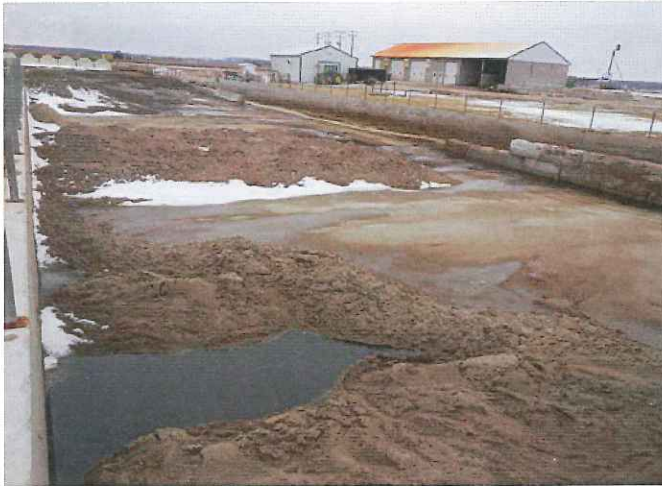
Top left: Photo of the sand separation system sand lanes. Photo taken facing south.

At the time of the inspection these systems appeared to be in good operating condition with adequate freeboard.

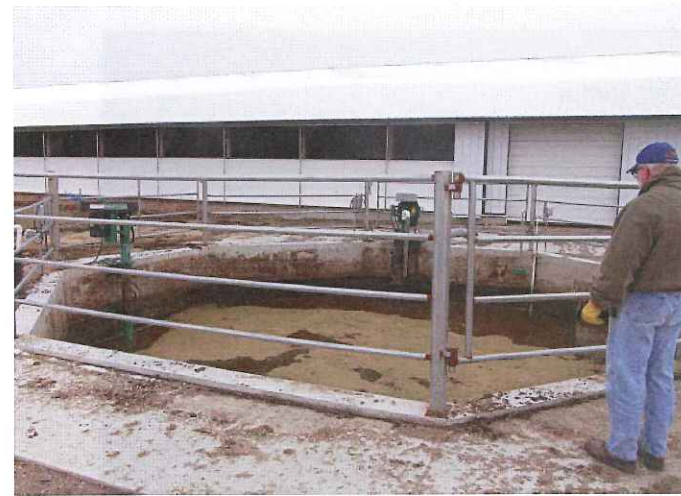
Top right: Photo of the flume system to/from the heifer barn. This structure has an MOL marker and mechanism in place to prevent overflow of the system. Photo taken facing north.

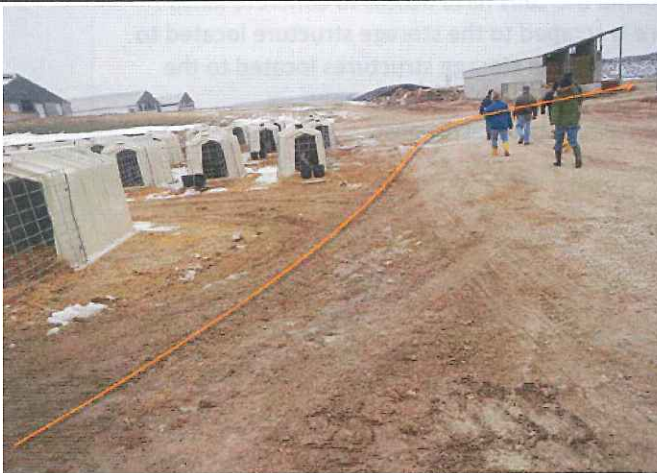
Top left(previous page): Photo of the east end of the calf hutch area. Calf hutches are cleaned at 2 months, clean bedding is added daily. Orange arrow indicates general calf hutch area runoff flow. At the time of the inspection a gravel berm was in place to direct runoff to the feed storage feed pad and runoff collection system. Photo taken facing north.

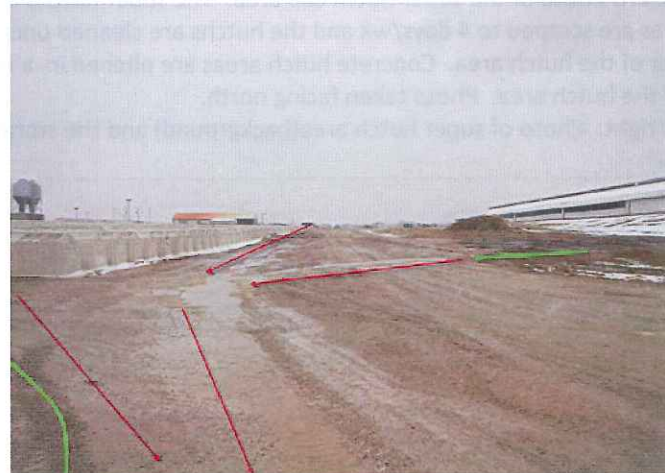
Top right(previous page): Photo of calf hutch area, driveway and stack of used hay. Red arrows indicates surface flow in area and the green lines are temporary gravel berms put in place to direct flow to feed storage runoff collection. Photo taken facing west.

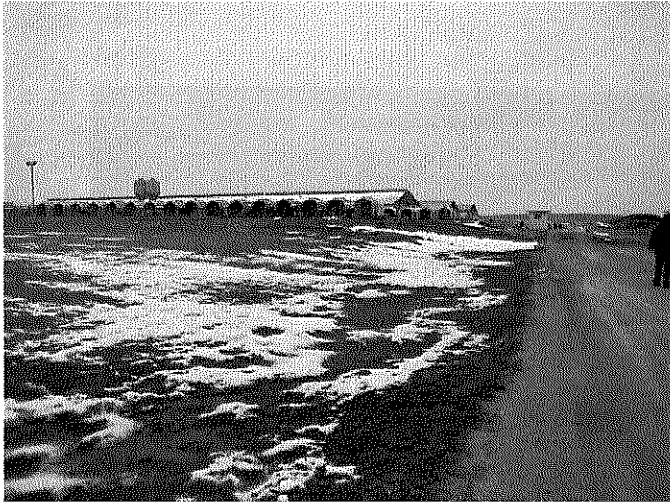
Bottom left: Photo of the super hutch calf area. The super hutches are kept on a concrete pad and the calves have access to concrete lanes. The lanes are scraped to 4 days/wk and the hutches are cleaned once every 2 months. Manure is scraped to the storage structure located to the west of the hutch area. Concrete hutch areas are pitched in a manner that all runoff is directed the storage structures located to the west of the hutch area. Photo taken facing north.

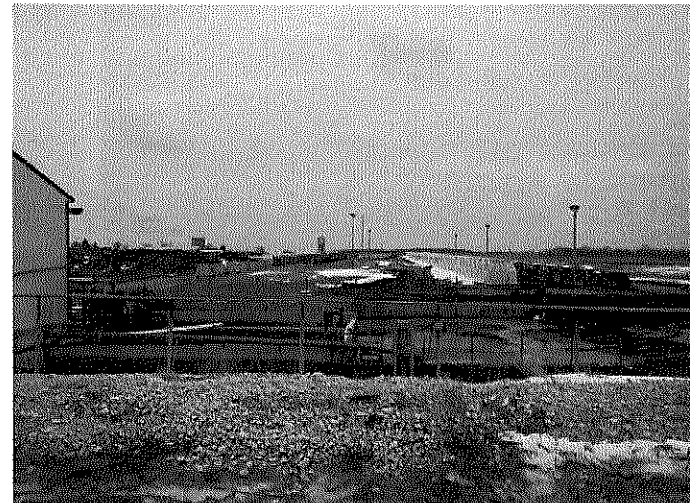
Bottom right: Photo of super hutch area(background) and the storage structures(foreground.) Photo take facing east.

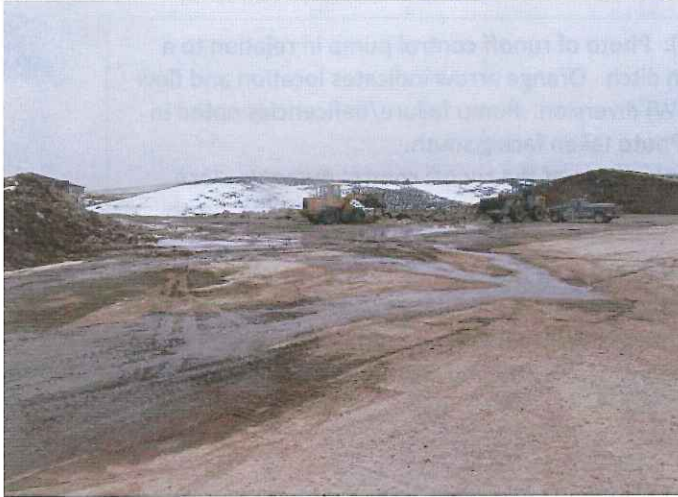
Top left: Photo of the feed storage area. Feed (corn silage and haylage) is stored on a concrete pad. The facility collects (send to manure storage) the first flush of runoff and the second flush will be sent to through a vegetated treatment area (VTA.) At the time of the inspection the facility was collecting 100% of the runoff and sending it to manure storage. Photo taken facing north west.

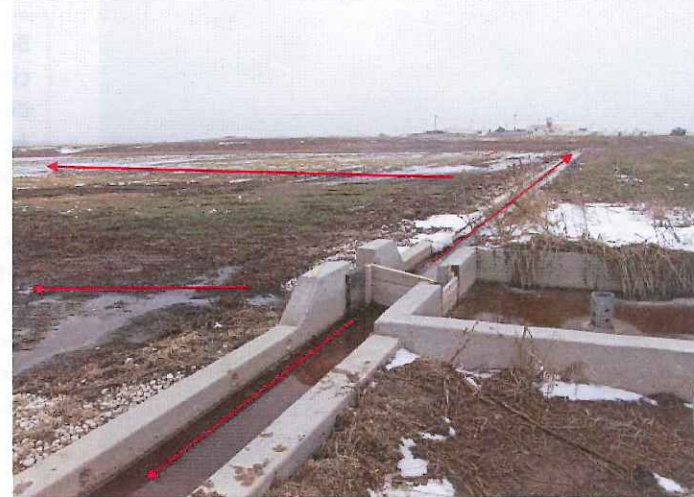
Top right: Photo of the runoff collection system, concrete spreader bar and VTA. Red arrows indicate flow directions through the spreader bars and across the VTA. Photo taken facing west.

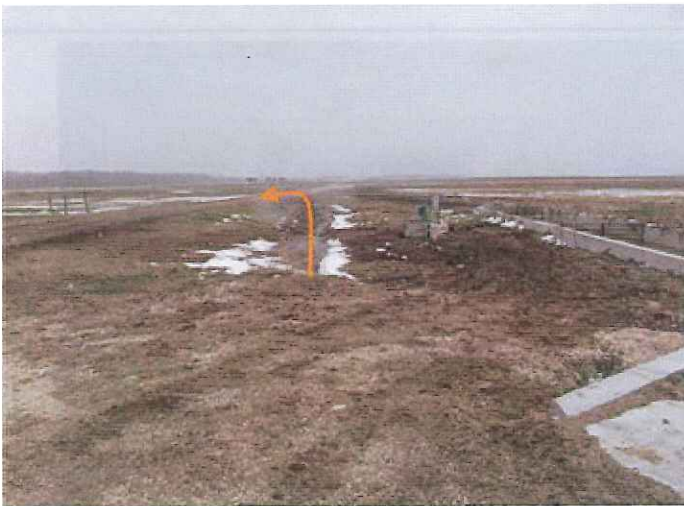
Bottom left(previous page): Photo of runoff control pump in relation to a clean stormwater diversion ditch. Orange arrow indicates location and flow direction of stormwater (SW) diversion. Pump failure/deficiencies noted in April 10, 2014 photo log. Photo taken facing south.

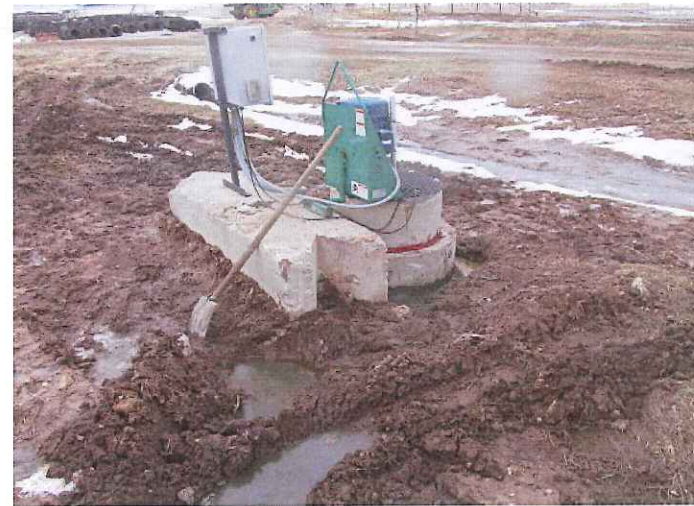
Bottom right(previous page): Photo of the runoff control pump up close. Repairs made to address leaks in the concrete. Photo taken facing north east.

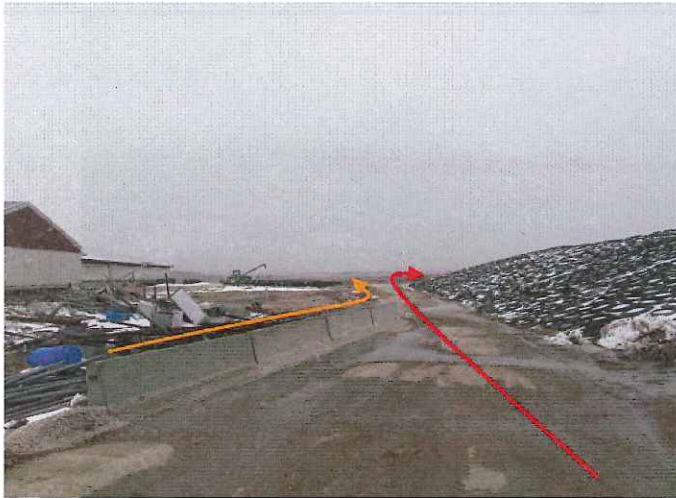
Left: Photo of feed storage area(runoff flow path in red) in relation to a SW diversion(flow path in orange.) Cement baracades in place for a portion of the SW diversion; at the time of the inspection no feed storage runoff to the SW diversion was observed. However wind blown feed was observed in the SW diversion.

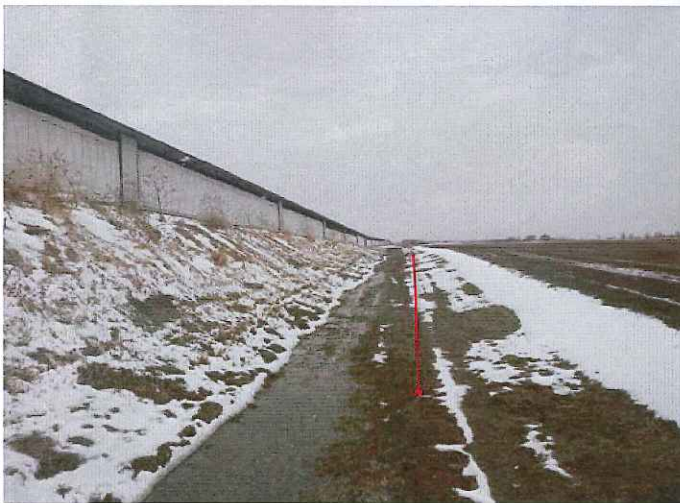
Left: Photo of the a SW diversion located north of the freestall barns. Water in this diversion is roof water. Photo taken facing west.

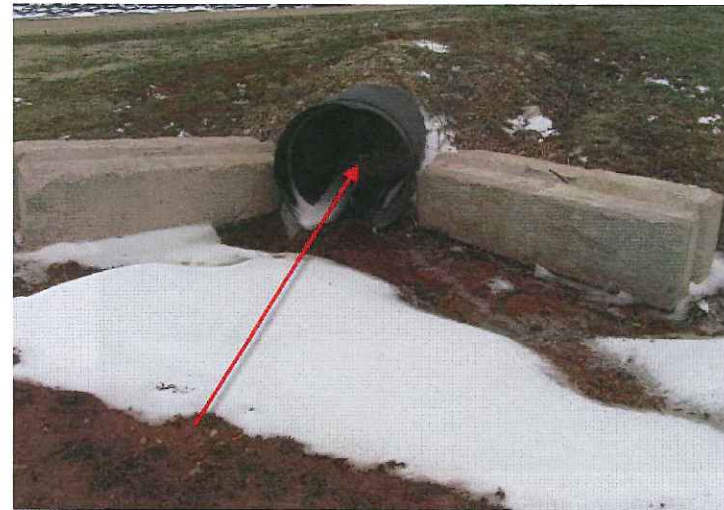
Right: Same SW diversion water as in photo on left being channeled through culvert; this water will travels through facility as shown in the next photos and discharge offsite. Water appeared clear. Photo taken facing south. Red arrows indicated flow direction.

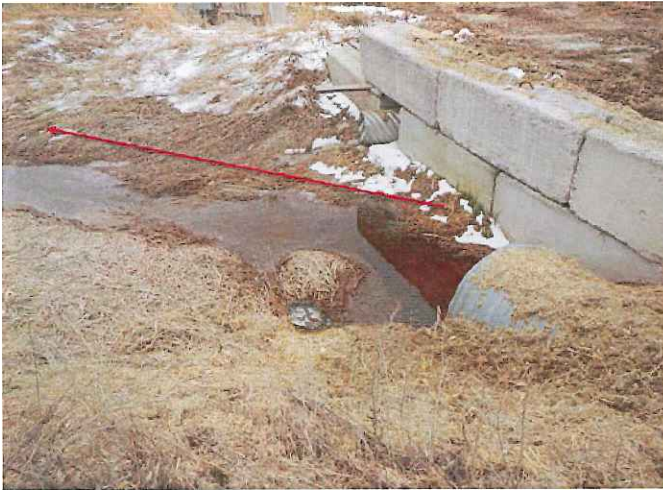
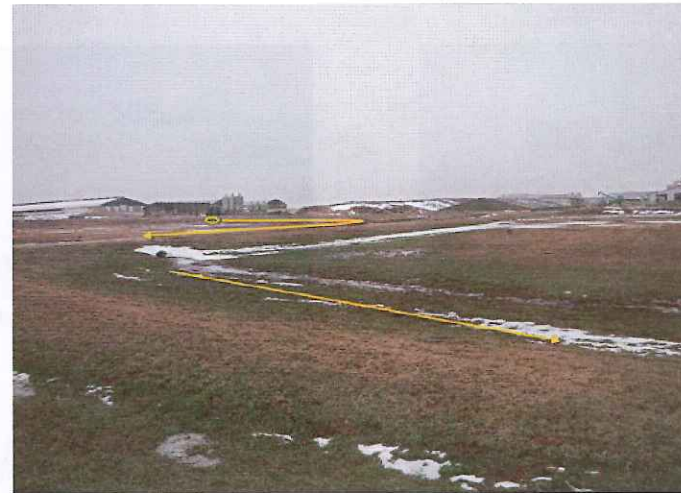
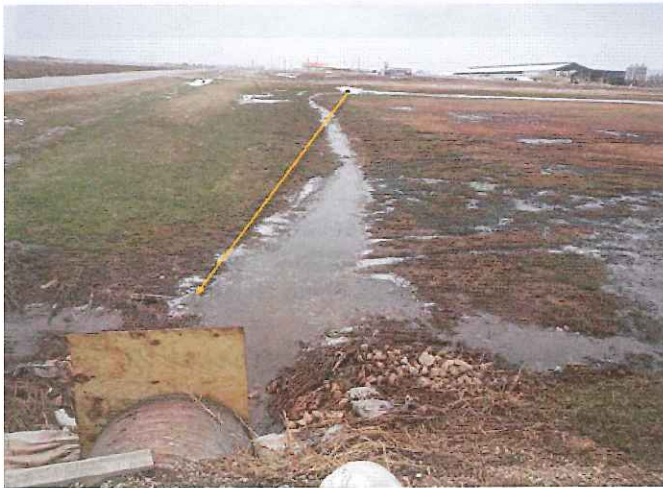
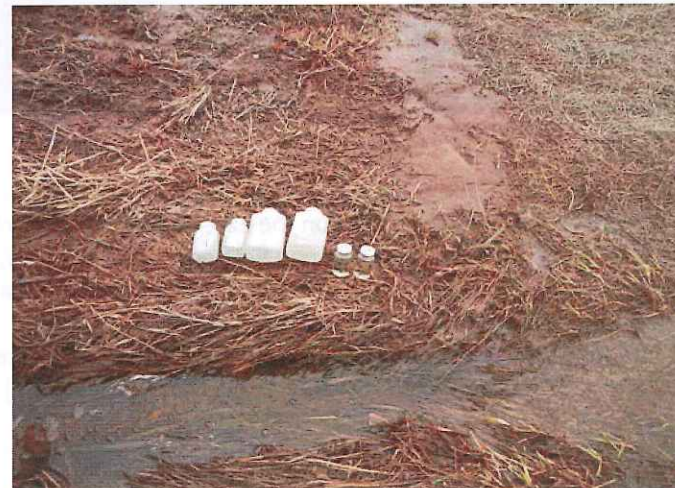
Top left: Continuation of the SW diversion, photo taken near calf hutch/feed storage area. Wind below feed observed in ditch area. Photo taken facing south.
Top right: Photo of same SW diversion flow path (orange arrow), yellow circle indicates approximate location of culvert previous in photo. Photo taken facing north west.
Bottom left: SW diversion flow path (orange arrow) to road culvert. Photo taken facing west.
Bottom right: Photo of sample bottles taken at Sample Point 2. See aerial map for sampling location. Photo taken facing south.

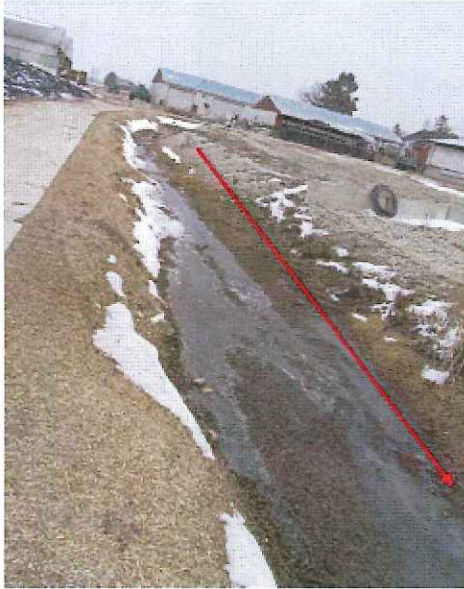
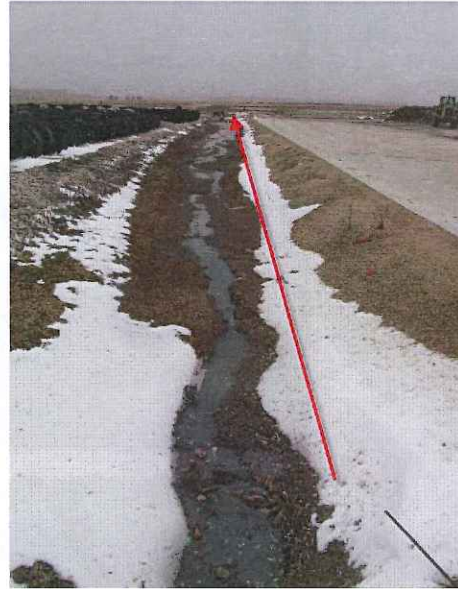
Left and Middle: SW diversion located on the east side of the facility between the feed storage area and abandoned heifer barn. The SW in the diversion originates from the a cropped field north of the facility; the cropped field is not operated by Dairy Dreams. Both ditches had wind blown feed within them, water with in the ditch was stagnet and dark in color. Red arrows indicate flow direction. Photo on left taken facing north and photo in middle taken facing south.

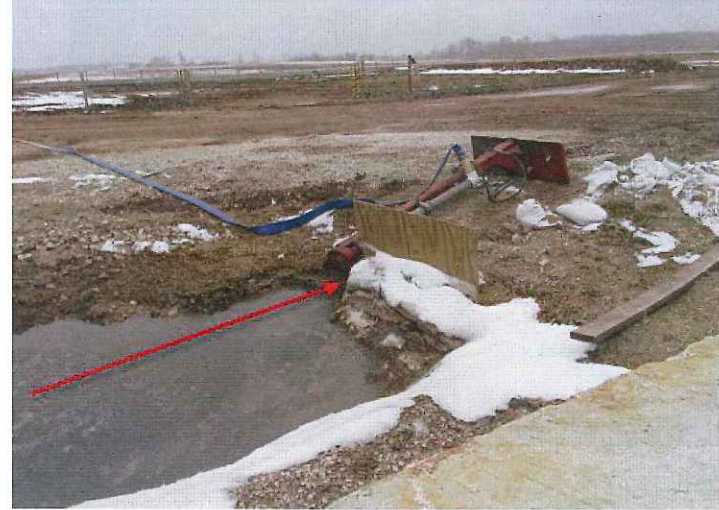
Right: Photo of ditch culvert blocked off; water within this ditch is being collected and put in to manure storage. Culvert has been blocked off since at least 11/15/2013(see photo log for 11/15/2013 inspection.) Photo taken facing south east.

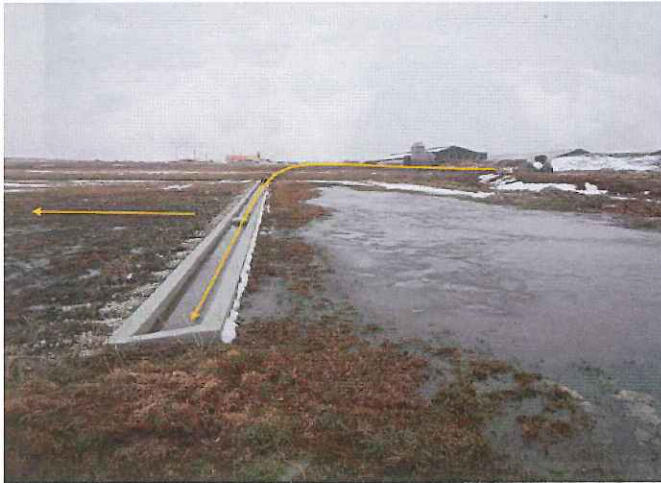
Left: SW from the ditch shown in the three previous pictures would flow through a ditch past the runoff control pump, through a access road culvert and into the spreader bar shown. Orange arrow indicates flow direction through ditch, spreader bar and accoss the VTA. The spreader bar and VTA shown in this picture were installe d for the purpose of treating SW that runs through the facility, these structures are not intended to treat process waste water from the feed storage area. Poned water located north of this spreader bar is likely from a combination of sources: SW, runoff from abandoned earthen lot area and runoff from feed storage area collection system(see photo log from 4/10/2014 site visit.) Photo taken facing west.

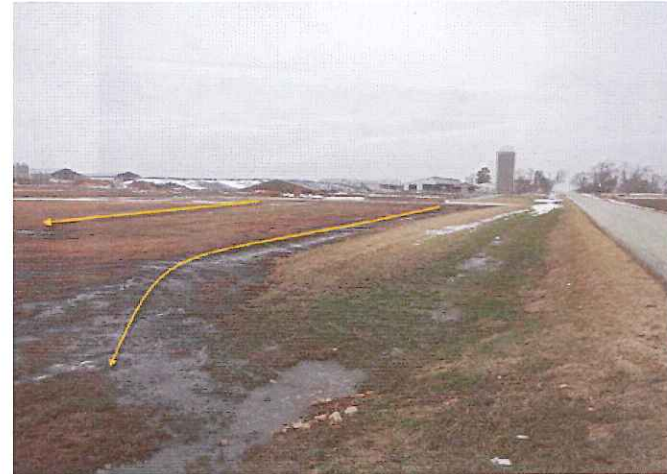
Right:Photo of the VTA for the SW. Orange arrows indicated flow direction through VTA. The arrow on the far right of the photo shows a channelize flow path that discharges to the road ditch near culvert. Photo taken facing north.

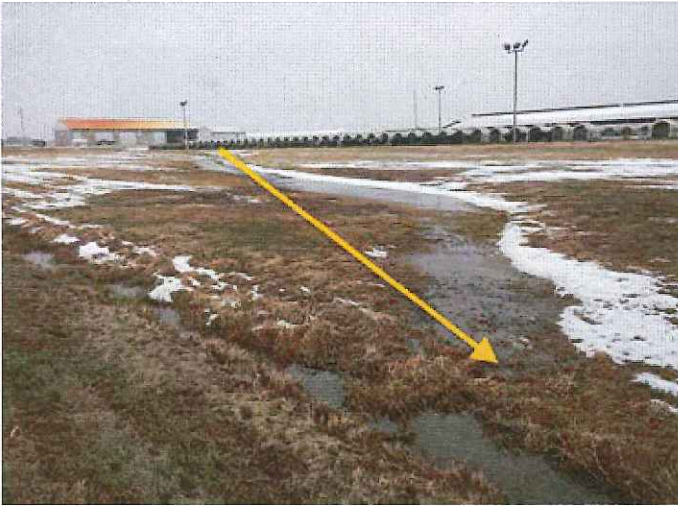
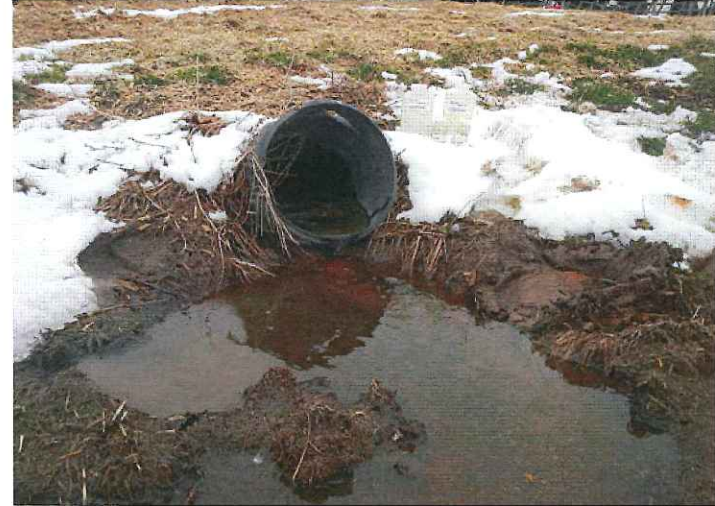
Left: Photo of SW drainage from under the concrete super hatch area. SW that would flow through this area would originate from the grassed area between the two super hatch areas. At the time of the inspection the culvert between the super hatch areas was blocked off. The observed water flowing underneath the super hatch area was said to be due to a broken water line (per Don Niles.) Don stated they are in the process of addressing the broken water line issue. Orange arrow indicated flow direction. Photo taken facing northwest.
Right: Photo of the culvert coming out the south side of the super hatch area and sample bottles at Sample Point 1. See aerial map for exact location of the sample site. Photo taken facing north.

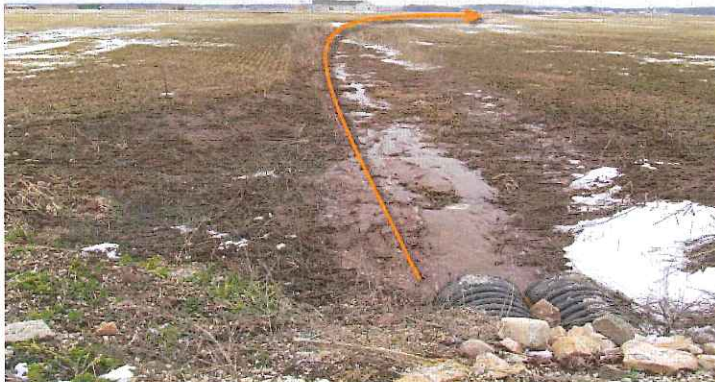
Left: Photo of a SW diversion located on the west side of the facility. Orange arrow indicates flow direction.

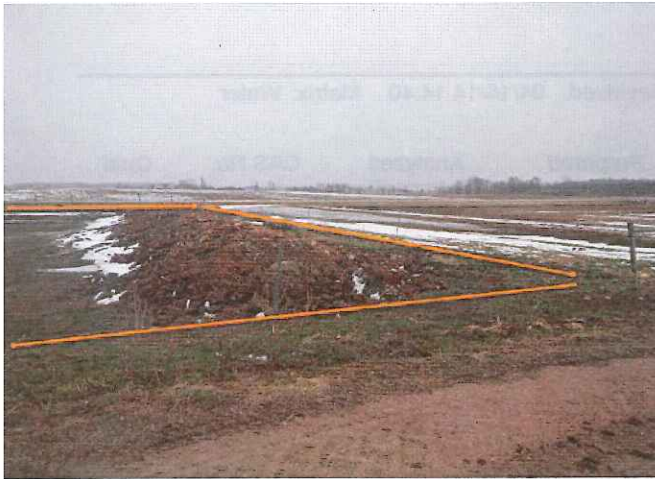
Left: Photo of the south portion of the abandoned heifer lot. Piles of material in photo are dirt. Orange line indicates boundry of lot. Photo taken facing east.

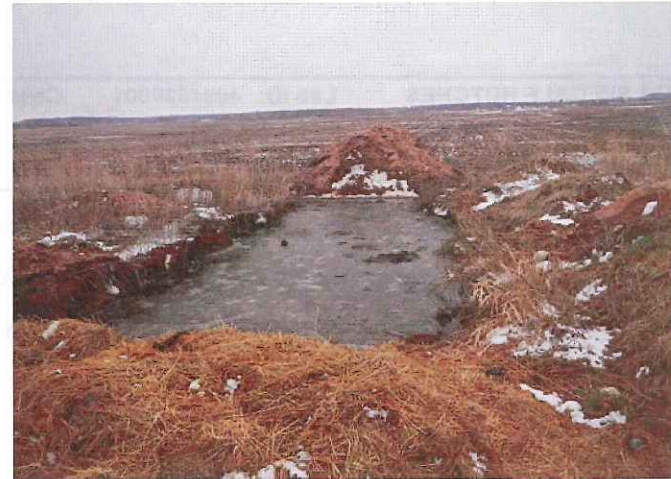
Right: Photo of used hay(from maternity barn) stacking area and small sump with manure/process wastewater within it located south of manure storage ponds. At the time of the inspection Block requested that Nile moved this material to an approved storage structure. No discharge from this storage area was observed. Materials were moved to storage and sumps was filled in by April 17th. Photo taken facing south.
